# IMPORTANT PRODUCT INFORMATION

**Product: VersaPro™ Programming Software Release 2.04**

GFK-1671P

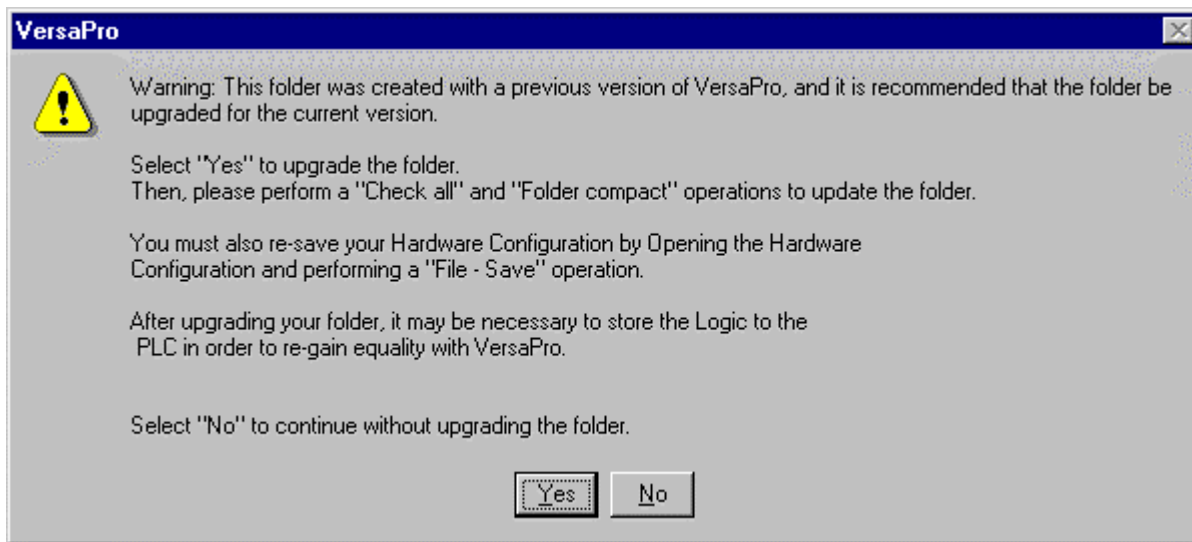
When opening VersaPro 1.x folders, the following dialog will be presented asking if you want to re-check the folder. The purpose of the re-check is to flag any syntax errors that were not being caught by 1.x versions and to update the folder to support the new functionality provided in VersaPro 2.0x. It is recommended that you select Yes, perform a check all on the folder and correct any syntax errors. After going through this process, the message will not be presented the next time the folder is opened. To avoid inequality issues with the PLC, it is recommended that you open hardware configuration, save it in the new format and store your logic to the PLC. These operations are required because new functionality has been added to the VersaPro 2.0x folders. However, the program and configuration are functionally equivalent to what was previously stored to the PLC using VersaPro 1.x.

If you open a folder created in a previous version of VersaPro, select Yes to the message below and re-check it, you will not be able to reopen the folder in the VersaPro build it was created in.

Selecting No will not force you to re-check the folder or correct any syntax errors. In addition, you will be able to gain equality with the PLC and monitor existing logic. However, the dialog shown below will appear each time the folder is opened and the logic portion of the folder will be in a read only state and will allow only limited operations.

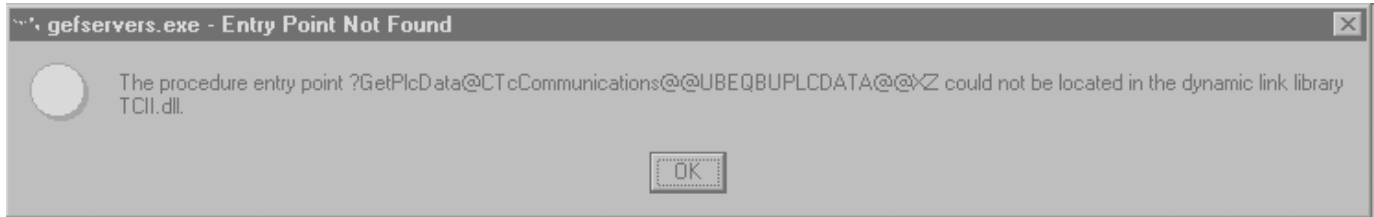
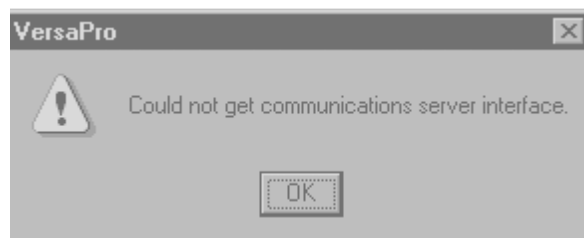
- After installing VersaPro 2.0x and then subsequently installing VersaPro 1.0x or 1.1x, you may receive the following error during the installation process:

In addition, you may not be able to connect to PLCs after the installation completes and the following error message may appear.

**Resolution:** A VersaPro 2.0x user wishing to install VersaPro 1.0x or VersaPro 1.1x can avoid this problem by following these steps:

- Uninstall VersaPro 2.0x: In the Windows Start menu, select Programs→GE Fanuc Software→VersaPro→Uninstall. You can also open the Control Panel's Add/Remove Programs, then select VersaPro for removal. (Uninstalling VersaPro 2.0x by letting the VersaPro 1.1x installer perform the uninstall should be avoided.)

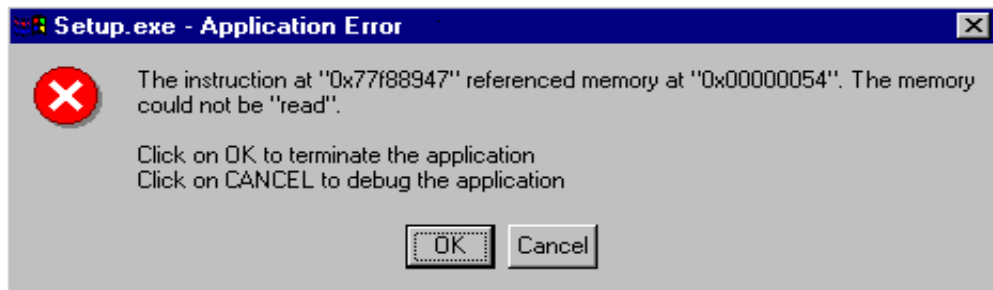
- **Application error while trying to install VersaPro 2.0x:** When running setup.exe to upgrade to VersaPro 2.0x, you may get the following error:

**Resolution:** Uninstall the previous version of VersaPro and delete the VersaPro directory along with any file left in this directory. Run the setup.exe to install the required version of VersaPro.
