IMPORTANT PRODUCT INFORMATION

Product: PACSystems™ RX7i CPUs with Firmware Version 1.50

IC698CPE010-BB (300 MHz)

IC698CPE020-BB (700 MHz)

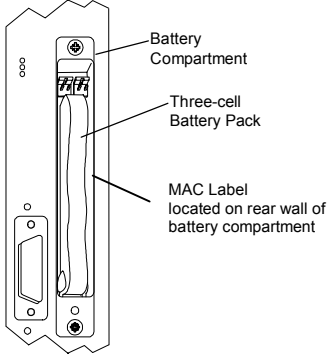
<i>Subject</i>	<i>Description</i>
MAC address	<p>A label on the rear wall inside the CPU's battery compartment identifies the MAC address assigned to the CPU's embedded Ethernet Interface. The label is visible when the battery is removed from its compartment. (The battery does not need to be disconnected to temporarily remove it from the compartment.)</p>

<p>The diagram shows a vertical battery compartment. At the top, there is a circular opening labeled 'Battery Compartment'. Below it is a 'Three-cell Battery Pack'. On the rear wall of the compartment, there is a small rectangular label labeled 'MAC Label located on rear wall of battery compartment'.</p>
Configuration of IP Address is Required Before Using Ethernet Communications	<p>The Ethernet Interface within the CPU module cannot operate on a network until a valid IP address is configured. The necessary Ethernet addressing information must be configured prior to actual network operation, or to recover from inadvertent changes to the Ethernet addressing data at the Ethernet Interface. Use one of the following methods to initially assign an IP address:</p> <ul style="list-style-type: none"> ■ Connect a serial terminal to the Station Manager port of the PACSystems RX7i . Then use the CHSOSW command to enter the desired IP address. For details, see Station Manager for the PACSystems RX7i, GFK-2225. ■ Temporarily assign an IP address to the module using the SetIP tool over the Ethernet network. For details, see TCP/IP Ethernet Communications the PACSystems, GFK-2224. ■ The Ethernet Interface automatically obtains a temporary IP Address from a BOOTP server on the network. For details, see TCP/IP Ethernet Communications for PACSystems, GFK-2224. <p>Once a temporary IP address has been set up, the Ethernet Interface can be accessed over the network (such as by the CIMPLICITY ME programming software). The programmer should then be used to configure the proper IP address for the Ethernet Interface.</p>
