IMPORTANT PRODUCT INFORMATION

Product: PACSystems™ RX7i CPUs with Firmware Version 1.60

IC698CPE010-BC (300 MHz)

IC698CPE020-BC (700 MHz)

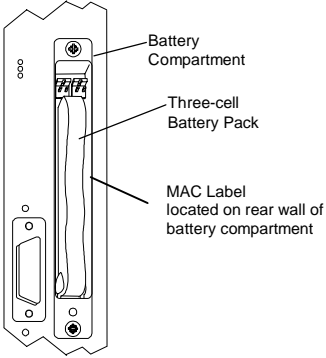
Subject	Description
MAC address	<p data-bbox="743 369 1084 667">A label on the rear wall inside the CPU's battery compartment identifies the MAC address assigned to the CPU's embedded Ethernet Interface. The label is visible when the battery is removed from its compartment. (The battery does not need to be disconnected to temporarily remove it from the compartment.)</p>

<p>The diagram shows a vertical battery compartment. At the top is the 'Battery Compartment' cover. Below it is a 'Three-cell Battery Pack'. On the rear wall of the compartment, there is a 'MAC Label'.</p>
Configuration of IP Address is Required Before Using Ethernet Communications	<p data-bbox="743 737 1453 898">The Ethernet Interface within the CPU module cannot operate on a network until a valid IP address is configured. The necessary Ethernet addressing information must be configured prior to actual network operation, or to recover from inadvertent changes to the Ethernet addressing data at the Ethernet Interface. Use one of the following methods to initially assign an IP address:</p> <ul data-bbox="776 911 1472 1230" style="list-style-type: none"> ■ Connect a serial terminal to the Station Manager port of the PACSystems RX7i . Then use the CHSOSW command to enter the desired IP address. For details, see <i>Station Manager for the PACSystems RX7i</i>, GFK-2225. ■ Temporarily assign an IP address to the module using the SetIP tool over the Ethernet network. For details, see <i>TCP/IP Ethernet Communications the PACSystems</i>, GFK-2224. ■ The Ethernet Interface automatically obtains a temporary IP Address from a BOOTP server on the network. For details, see <i>TCP/IP Ethernet Communications for PACSystems</i>, GFK-2224. <p data-bbox="743 1243 1453 1375">Once a temporary IP address has been set up, the Ethernet Interface can be accessed over the network (such as by the CIMPLICITY ME programming software). The programmer should then be used to configure the proper IP address for the Ethernet Interface.</p>
